## SAS Superstructure

### Daily Diary Report by Bid Item

04-0120F4  
04-SF-80-13.2/13.9  
Self-Anchored  
Suspension Bridge

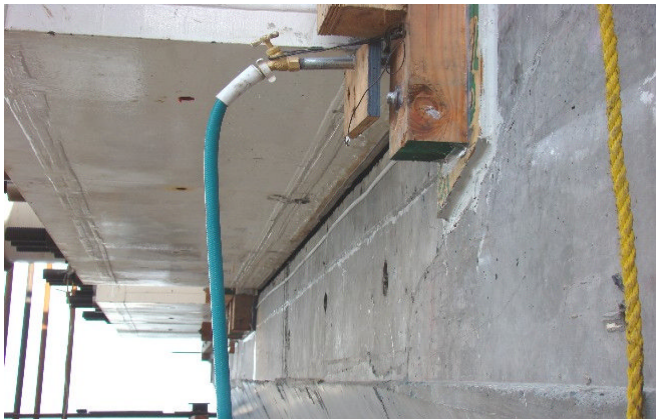
Bottom of the South W2W Hinge K pipe beam assembly grout pad forms removed in preparation for cleaning debris from the forms.

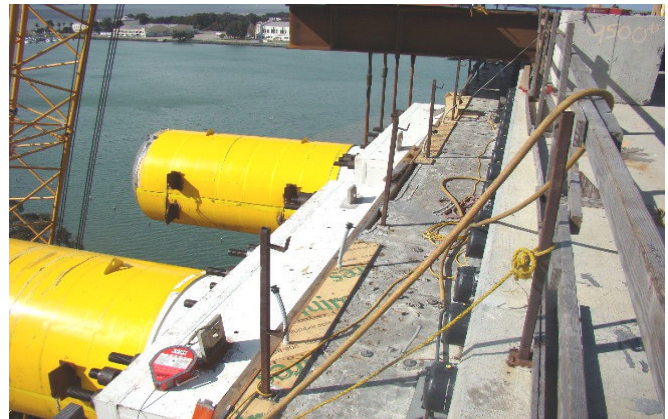
Conco carpenters began to place outlet grout tubes at the top of the forms for both pairs of hinge grout pads.
